Biogas plant explosion protected early streamer emission (ESE) air terminal

Ing. Jiří Kutáč, Union of Court's Expert
 Doc. Ing. Zbyněk Martínek, CSc., University of West Bohemia, Faculty of Electrical Engineering
 Ing. Jan Mikeš, Czech Technical University, Faculty of Electrical Engineering
 nprap. (CW-1) Martin Petrák, HZS JčK territorial Division Tábor

The designer suggested the lightning protection of biogas plant according to French standard NF C 17-102. Yet there was a direct lightning strike to the top of the fermenter, which lay in the protected space ESE air terminal. After a lightning explosion occurred and fire broke out subsequently biogas plant. Control measurement ESE air terminal demonstrated its full functionality at the time of intervention. 10 minutes before the lightning and the subsequent explosion of biogas leaving 4 workers that area due to changes in climatic conditions (rain beginning).

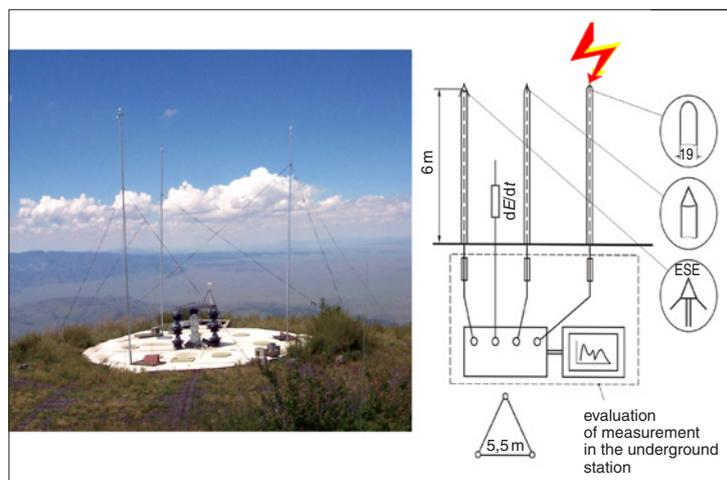
Fig. 1. Measuring system at the peak of South Baldy in New Mexico (USA)

Three types of lightning conductors, each 6 metres long (Fig. 1), were installed in an outdoor laboratory in New Mexico, USA, on Mount South Baldy at an altitude of 3,287 metres above sea level:

- ESE lightning conductor,
- Lightning conductor topped with a pointed head,
- Lightning conductor topped with a round head.

The distance between each lightning rod was 5.5 metres and devices for measuring lightning current were installed underground. Only strikes to the lightning rods topped with a round head were registered during a period of eight years.

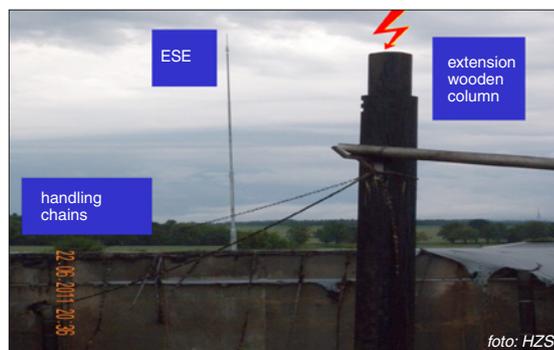
Fig. 3. The damaged technological part of fermenter after lightning strike in a protective area ESE

A lightning struck the upper section of the fermenter of the biogas station at Malšice (Fig. 3) [17] probably after 8:00 p. m. that day. A fire broke out and a partial explosion occurred on the technological parts of the fermenter (Fig. 4) due to the physical

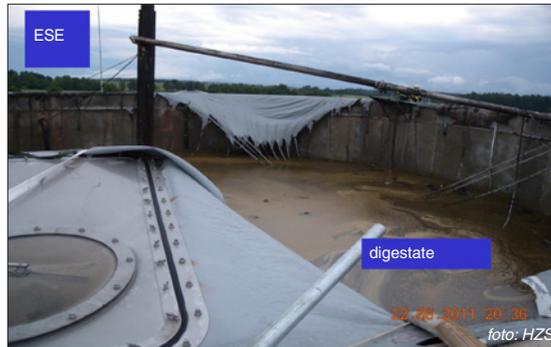
Fig. 6. View into the damaged inner tank of fermenter, which is located in the protective area of ESE

The first unit of the fire rescue corps arrived on the site at 8:23 p. m. The inner as well as outer containment, particularly on the southern side of the fermenter, was hit by fire (Fig. 6). The outer containment, forming the roof protective shield against atmospheric effects, is made of layered fabric composed of the following:

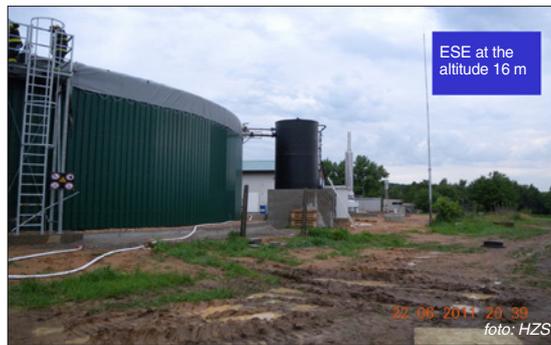
Fig. 7. Overall view of the location of the ESE, which is located 13 m from the edge of the fermenter

To achieve the required safe load and strength of the outer sheet, polyester straps are woven into the fabric, being anchored in the upper section on a steel head of the wooden pole and on the outside of the circumferential pit of the fermenter (Fig. 7). The inner sheet serves as a membrane gas tank and is made of a fabric composed of the following:

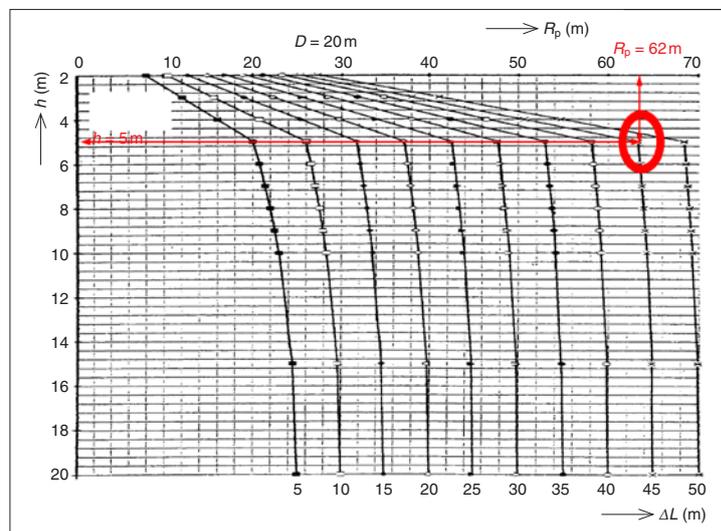
Fig. 8. Table for determination of the protective radius R_p according to the NF C 17-102

- NF C 17-102 – pursuant to Article 2.2 [3] method of protective radius R_p , given by the speed of streamer $v = 100 \text{ cm}/\mu\text{s}$ [1]. This prerequisite does not respect the natural behaviour of lightning discharge (Fig. 8),
- ČSN EN 62305-3 – pursuant to Article 5.2 [10] method:
 - rolling sphere,
 - protective angle,
 - the mesh method.

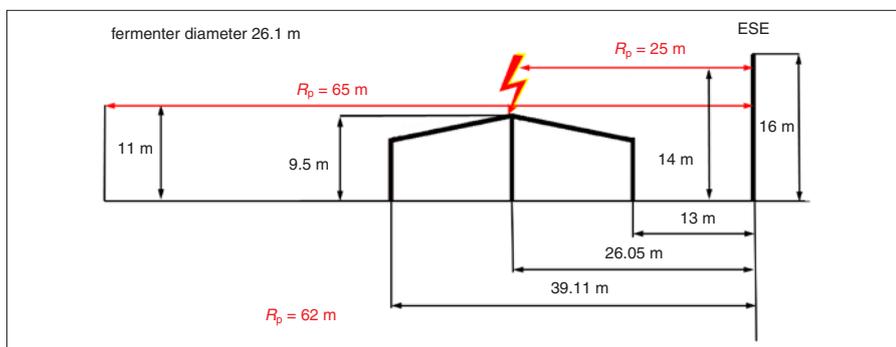
Fig. 9. Stroke to the upper part of fermenter, i. e. right in the middle of the ESE protective cone

The outcome of the incorrect design of lightning protection pursuant to the NF C 17-102 standard [3] is that lightning struck the upper section of the fermenter, situated only 26.05 metres from the ESE lightning conduc-

tor. However, the protective radius (protective cone) of the given ESE lightning conductor amounts to $R_p = 62$ metres (Fig. 9).

- Lightning struck directly in the middle of an alleged protective radius R_p of the ESE lightning conductor protecting the fermenter against lightning (Fig. 9).
