CIGRE C4 Colloquium on  
Lightning and Power System,  
Kuala Lumpur, 16 – 19 May, 2010

**MISCONCEPTIONS ABOUT LIGHTNING AND ITS RELATION  
TO AIR TERMINAL DESIGN ERRORS  
(Invited paper)**

Z. A. Hartono & I. Robiah  
Senior Members IEEE

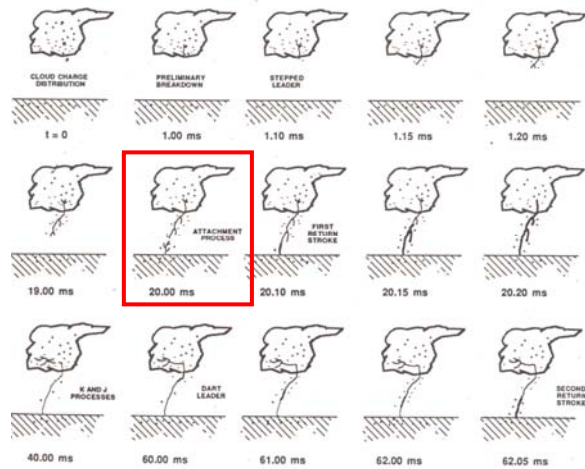
# Lightning discharge process

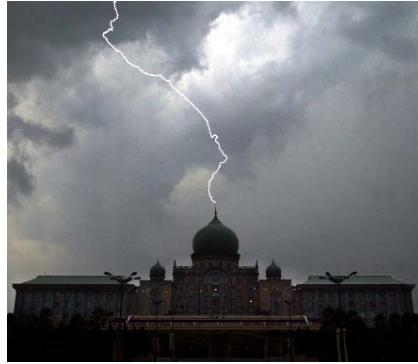
- Lightning strikes thousands of structures on the ground annually
- In most cases, they attach themselves to the corners and edges
- Sometimes it strikes the highest point of a structure

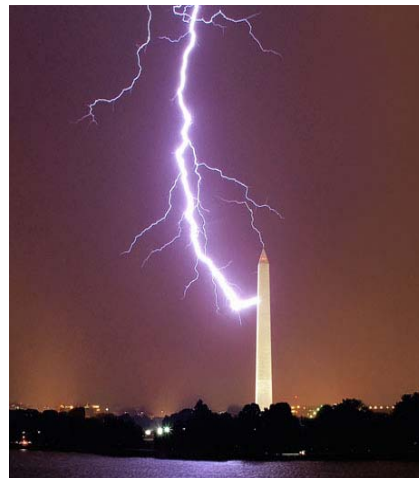
- On rare occasions, lightning can also strike the sides of tall structures

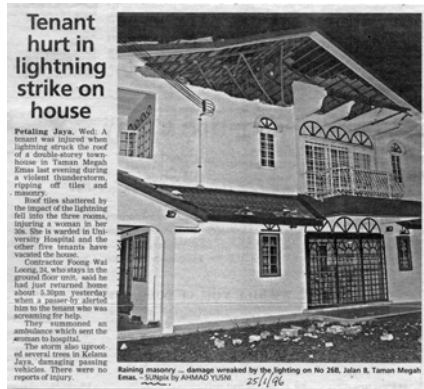
- Less than 5% of bypasses resulted in
  - Structural damages
  - Fire outbreaks

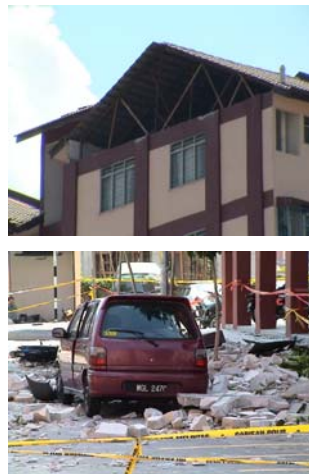
- Lightning attachment on ballast concrete can result in large bypasses
  - Concrete material is very light and fragile
  - No rebars were used

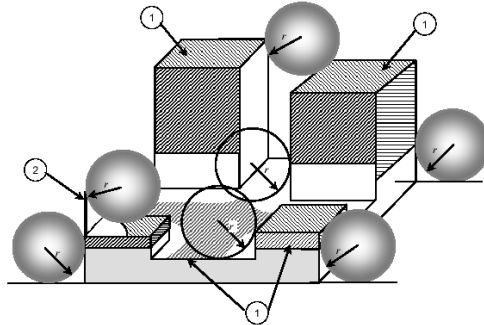
- Parts of the structure touched by the sphere require protection
- However, the method makes no differentiation between high and low risk parts

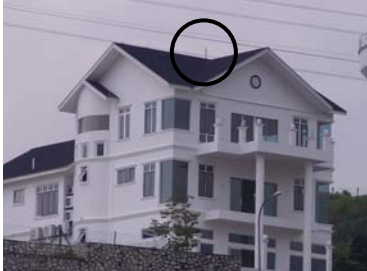
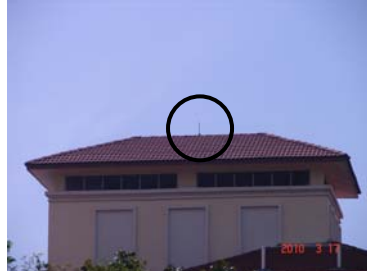
- Single air terminal positioned on the highest point of structure
- High risk locations left exposed to lightning

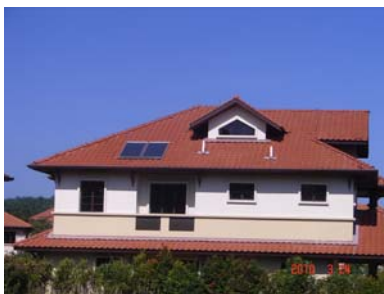
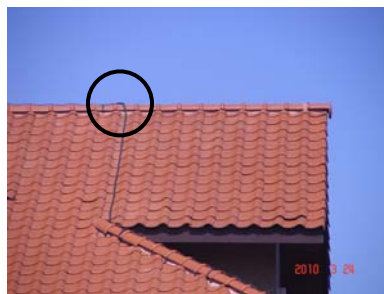
- Air terminals arbitrary positioned on the structure, avoiding the high risk locations
- High risk locations left exposed to lightning

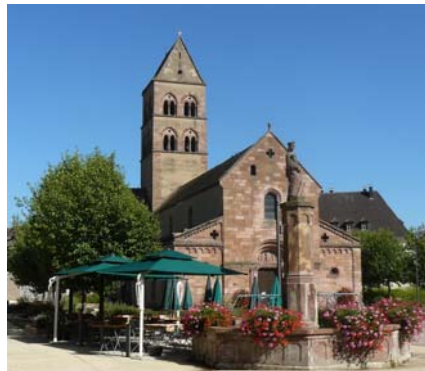
- On May 21, 2009, lightning struck the bell tower of a 12<sup>th</sup> century Saint Pierre and Paul church in Sigolsheim, France
  - [http://www.gs-ing.com/gest/gest/up/1245414572\\_Un%20clocher%20foudroye%20a%20Sigolsheim..pdf](http://www.gs-ing.com/gest/gest/up/1245414572_Un%20clocher%20foudroye%20a%20Sigolsheim..pdf)
- Bell tower is only about 30m high and was installed with an ESE air terminal

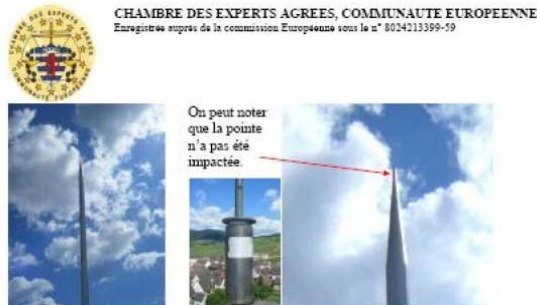
- Inspection of the ESE air terminal showed no impact from lightning
- This is clear evidence that ESE technology cannot protect even a small structure from lightning
